## **Restoration of dynamic flood plain topography and riparian vegetation establishment through engineered levee breaching**

**Abstract** Engineered levee breaches on the lower Cosumnes River, central California, create hydrologic and geomorphic conditions necessary to construct dynamic sand splay complexes on the flood plain. Sand splay complexes are composed of a network of main and secondary distributary channels that transport sediment during floods. The main channel is bounded by lateral levees that flank the breach opening. The levees are separated into depositional lobes by incision of secondary distributary channels. The dynamic topography governs distribution of dense, fast-growing cottonwood (*Populus fremontii*) and willow (*Salix* sp.) stands. In turn, establishment and growth of these plants influences erosional resistance and roughness, promoting local sedimentation and scour. Cottonwood and willow establishment is associated with late spring flooding and the occurrence of abundant bare ground.

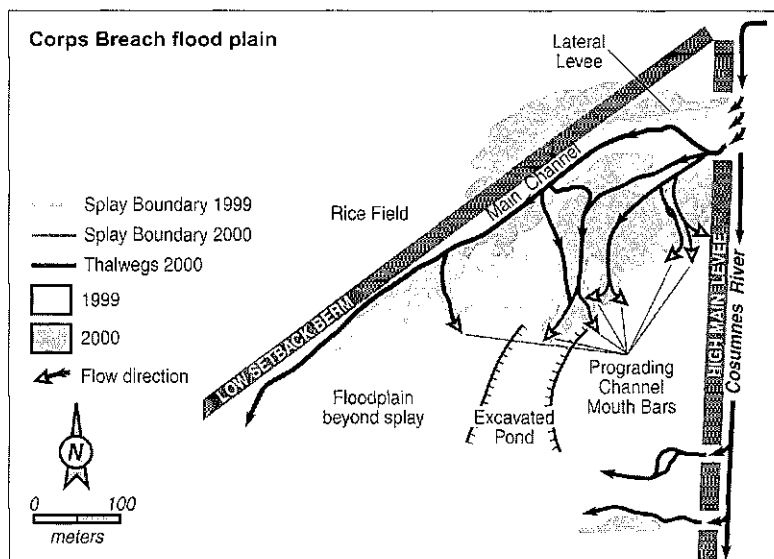
**Fig. 2** Generalized geomorphic map of the Corps Breach constructed during fall of 1997. Note complex morphology and growth patterns of sand splay complex due to set back levee (modified from Florsheim & Mount, 2002).

The Nature Conservancy (TNC), along with its partners in the Cosumnes River Preserve, are conducting an extensive management and restoration programme in the lower Cosumnes River that focuses on wildlife-friendly agriculture and restoration of riparian, flood plain and wetland habitats (Andrews, 1999; TNC, 2000). Based on observations of successful establishment of riparian forests on sand splay deposits formed by historic levee failures, the Preserve partners experimented with intentional levee breaching in two locations: the Accidental Forest Breach, constructed October 1995, and the Corps Breach, constructed October 1997. Both breaches discharge water and sediment onto former agricultural fields that were graded and levelled prior to restoration. At the Corps Breach, a low set-back berm that deflects flows away from adjoining rice fields, and an excavated 2-m-deep “wildlife pond” were graded as part of the restoration project (Fig. 2).

At the two study areas, elongate sand splay complexes are developing adjacent to and down-flood plain from the breach openings (Figs 2, 3). The two complexes differ in geometry, thickness and complexity, reflecting differences in initial grading of the restoration sites prior to breaching. Both complexes are accumulating significant volumes of sediment, extending as much as  $0.5 \text{ km}$  down-flood plain from the breach.

**Lateral levees/depositional lobes** The most significant vertical accretion that occurs in sand splay complexes takes place on lateral levees that form adjacent to the main distributary channel and the breach scour (Figs 2, 3). The levees are formed through turbulent diffusion of sand in secondary flow cells of the main distributary channel into the flow separation eddies that flank the breach opening. The construction of the lateral levees creates the maximum elevations within the splay complexes and, as is shown below, plays a key role in the establishment and growth of riparian vegetation. The lateral levees of the splay complex are separated into depositional lobes incised by distributary channels. The lobes have highly irregular topographic surfaces that are extensively modified by small overwash channels and by high velocity flows that exceed distributary channel capacity.

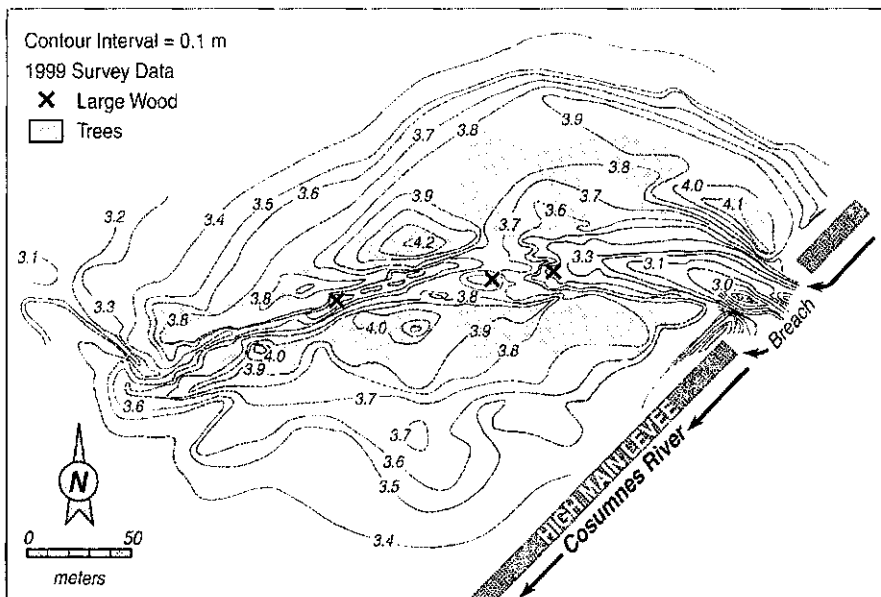
**Fig. 3** Topography of sand splay complex at Accidental Forest, surveyed in September 1999. Pattern indicates areas of dense cottonwood and willow establishment and growth.

**Distributary channels** A main distributary channel originates from the lowest elevation in both breaches and extends through the entire length of the sand splay complex. Each main channel contains a breach scour zone (Fig. 3) that is flanked by lateral levees. Sequential surveys indicate that the scour zone deepens following the initial opening of the breach and, over time, extends down-flood plain, maintaining a negative slope. Within the Corps Breach (Fig. 2), and to a lesser extent within the Accidental Forest Breach (Fig. 3), the main distributary channel bifurcates into one or more sand-bedded, secondary distributary or anastomosing channels, each containing a channel mouth bar. Extension of the splay complex channels takes place through progradation of distributary mouth bars.
